KOZZA RAILING SYSTEMS

BALUSTRADE TESTING IN ACCORDANCE WITH BS 6180:2011

DOCUMENT REFERENCE: DR-5577
PROJECT FILE REFERENCE: P10159

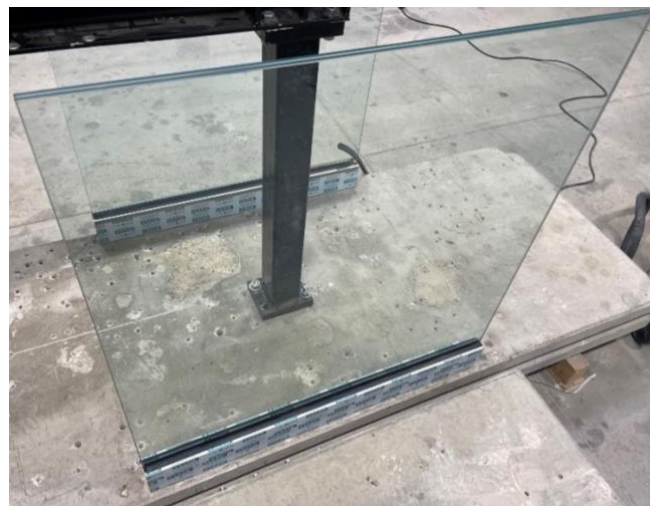
TEST DESCRIPTION: A series of loads were applied to the balustrade system at a height of 1100mm and width of 1000mm to determine the deflection of the balustrade system when assembled. All testing were carried out in accordance with BS 6180:2011.

TEST DETAILS:			
Product Tested:	KE100 (16mm)	Item Condition:	New
Target Load:	0.74kN	Ambient Temperature:	18°C
Test Location:	STS Laboratory	Procedure or Method:	BS 6180:2011
Test Number:	Two

Test	Target Load	Load Achieved	Maximum Displacement (mm)	Classification
Line Load	0.74kN/m	0.74kN/m	18.91	Pass
Infill	1.00kN/m ²	1.00kN/m ²	3.72	Pass
Point	0.50kN	0.50kN	5.06	Pass

Testing was completed successfully with the balustrade system achieving loading values for the 0.74kN specification, with a maximum recorded displacement of 18.91mm, resulting in a pass. All testing was carried out in accordance with BS 6180:2011.

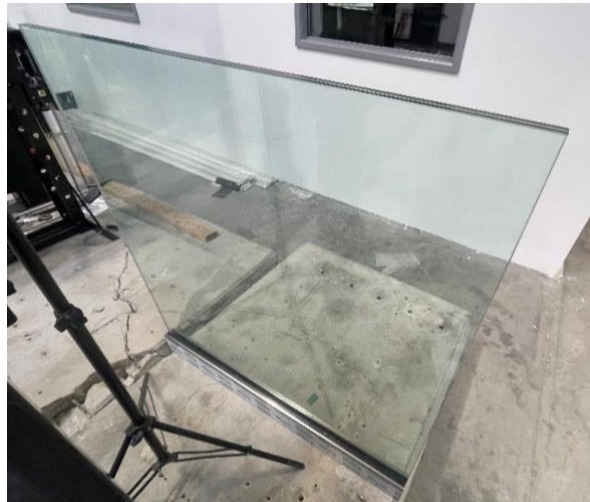
TEST DESCRIPTION: A series of loads were applied to the balustrade system at a height of 1100mm and width of 1000mm to determine the deflection of the balustrade system when assembled. All testing were carried out in accordance with BS 6180:2011.

TEST DETAILS:			
Product Tested:	KE100 (20mm)	Item Condition:	New
Target Load:	0.74kN	Ambient Temperature:	18°C
Test Location:	STS Laboratory	Procedure or Method:	BS 6180:2011
Test Number:	Three

Test	Target Load	Load Achieved	Maximum Displacement (mm)	Classification
Line Load	0.74kN/m	0.74kN/m	23.47	Pass
Infill	1.00kN/m ²	1.00kN/m ²	8.03	Pass
Point	0.50kN	0.50kN	4.24	Pass

Testing was completed successfully with the balustrade system achieving loading values for the 0.74kN specification, with a maximum recorded displacement of 23.47mm, resulting in a pass. All testing was carried out in accordance with BS 6180:2011.

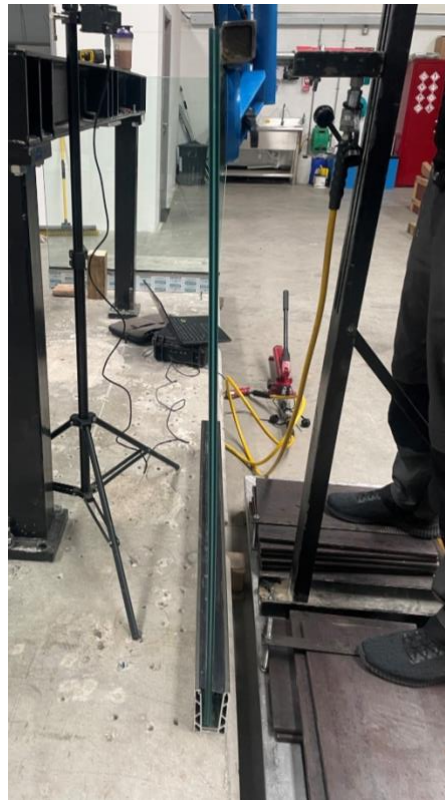
Figure 1 – UDL Example

Horizontal uniformly distributed line load should be applied at design height as presented in Table 1 or at design level (1 100 mm) for barriers higher than the design height.

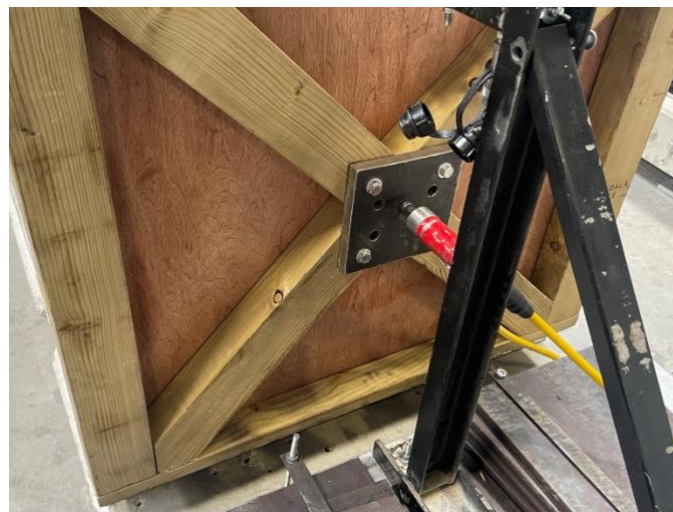
Figure 2 – Infill Test Example

Uniformly distributed load should be applied to the area below the design height.

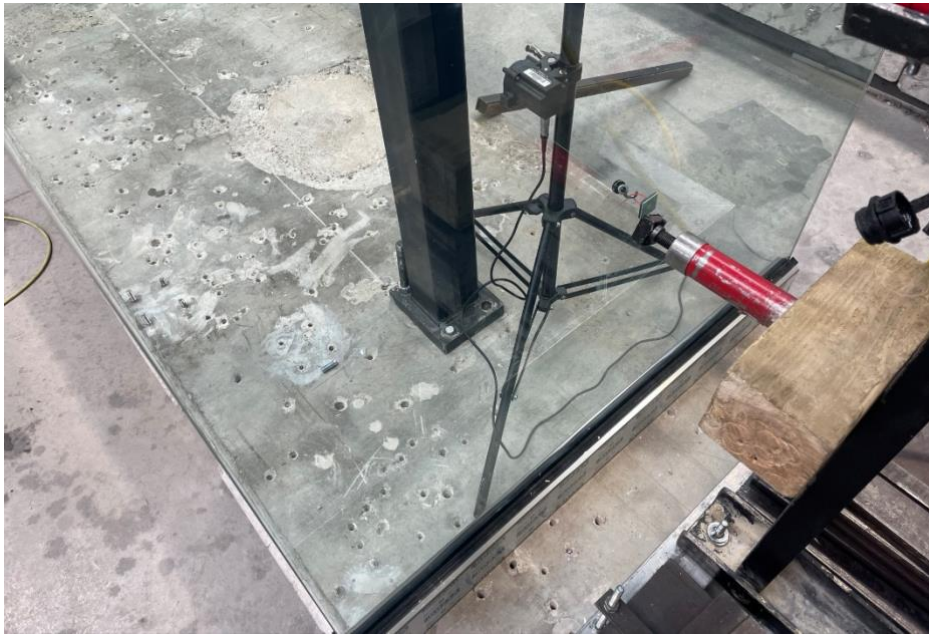
Figure 3 – Point Load Example

Point load should be applied at the most onerous point anywhere on the barrier structure.
